CCATCH @ Solent Breezes: Community Workshop on 26th September 2013

Workshop report

Solent Breezes Coastal Defence Assessment

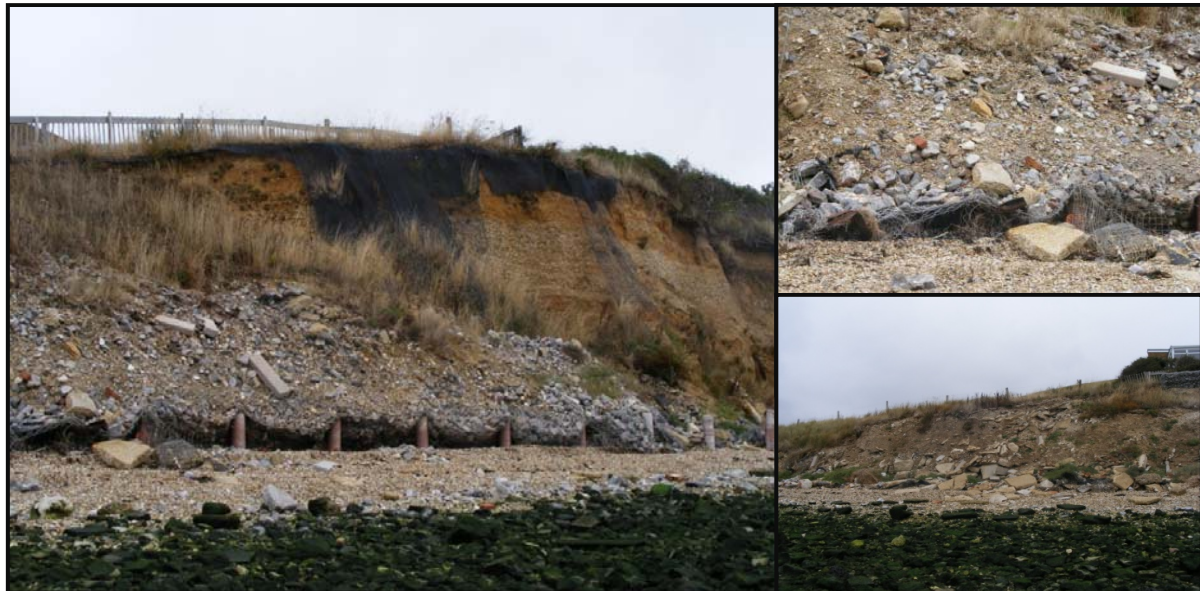
Figure 3: *general arrangement of Defence Length 1, including a detailed image of waste*

Condition Description: The gabions are showing substantial loss of stone, failure of wire mesh, washout and movement of units, misalignment, crest reduction and are beyond economic repair. Whilst the concrete piles are intact they are no longer serving a defence function as the gabion units they once stabilised have failed. The cliff stabilisation netting is torn and disconnected, no longer serving any defensive function.

Condition Grade: 5 - Very Poor, severe defects resulting in complete performance failure

General Comments: This frontage length has considerable waste materials such as concrete blocks, wire mesh, old damaged geotextile, cliff netting and concrete piling. The waste is unsightly and a health and safety and environmental concern. The failed defences appear to be acting as a barrier to alongshore sediment transport and a headland is developing at the south-eastern end of the frontage. Site clearance in this location may promote some north-westwards movement of local beach material, although the amounts are uncertain given the sediment transport drift divide that is understood to be present in this area.

Option 1: Site clearance and construction of a rock toe - Site clearance will facilitate a clear and consistent frontage length on which to build upon. The defence line would also be brought back to the foot of the cliff as opposed to the foot of the existing failed defences. A rock toe will provide protection to the foot of the cliffs from erosion and reduce cliff recession.

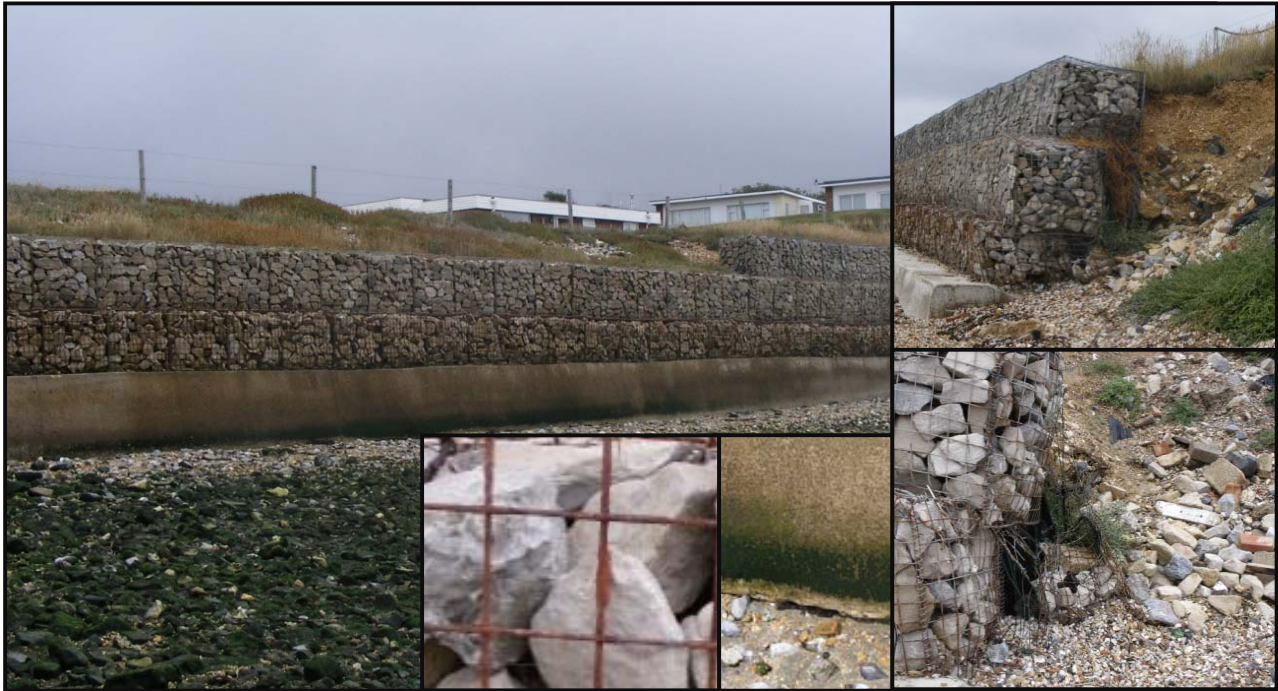
Figure.4: *general arrangement of Defence Length 2, including detailed images of undercutting, damage and corrosion*

Condition Description: The gabion wall is showing good rock packing with no noticeable loss of stone for the majority of units. There are no signs of settlement or bulging. The wire mesh is showing signs of corrosion and the mass concrete toe wall has evidence of undercutting. At chainage 45m (adjacent to Defence Length 1) where the gabion wall begins, there is increased cliff erosion and a unit has failed (see Figure 4).

Condition Grade: 3 – Fair, defects that could reduce the performance of the asset

Option 1: Sheet pile with mass concrete backfill or rock armour toe protection – the undercutting of the mass concrete toe wall threatens the overall stability of the gabion wall structure and without protection, may lead to failure (See Defence Length 4).

Option 2: Rock armouring to the gabion wall/cliff interface at chainage 45m – exposure in this region may give rise to progressive failure of the gabion wall, a unit has already failed during a short time frame. Rock armour will protect the edge of the gabion wall and reduce cliff erosion at this location, providing a graduation between the soft cliffs and the hard defence structure.

Option 3: Replacement of gabion wall wire mesh – the structure is showing visible corrosion of the wire mesh and in time this will lead to damaged units, a loss of stone fill and the beginning of gradual collapse in the form of crest reduction and bulging.

All of the above measures would lead to an improved life span of this defence and given its recent installation and the defects identified; consideration of all or a combination thereof is advised.

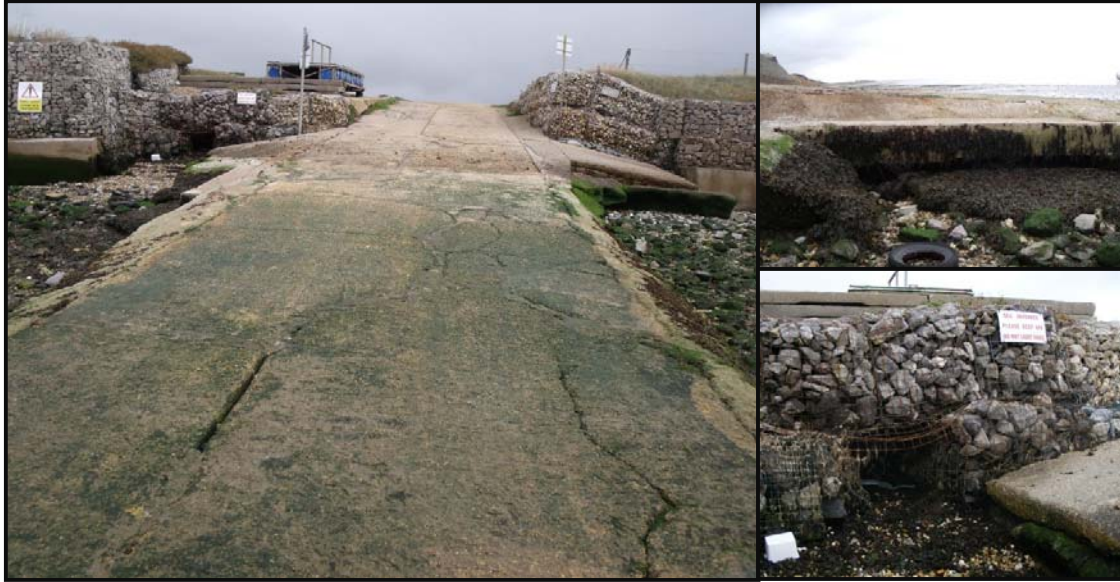
Figure 5: general arrangement of Defence Length 3, including detailed images of undercutting and gabion damage

Condition Description: The structure is showing signs of localised spalling, lengthy cracking and some movement (particularly at the edges). There are signs of localised undermining around the slipways edges and slumping. The gabions are showing some signs of settlement and distortion with reasonable packing and small loss of stone. There is a unit which has failed (shown in Figure 5) and mild corrosion of the gabion mesh is evident.

Condition Grade: 3 – Fair, defects that could reduce the performance of the asset

General Comments: The access slope from the slipway to the western frontage appears to have been removed or damaged. This would have provided some defence to the gabion units behind which are becoming damaged as well as safe access. Sheet piles have been used at the immediate toe of the slipway to counter scour and undermining.

Option 1: Sheet piling and mass concrete backfill to edges of slipway - this will help to protect the edges of the slipway which over time will continue to be undermined, leading to further cracking and spalling.

Option 2: Repair to gabion units – where entire units have been lost these should be replaced as it introduces an area of structural weakness which could rapidly develop and lead to progressive failure if not corrected.

Option 3: Replacement of gabion wall wire mesh – the structure is showing visible corrosion of the wire mesh and in time this will lead to damaged units, a loss of stone fill and the beginning of gradual collapse.

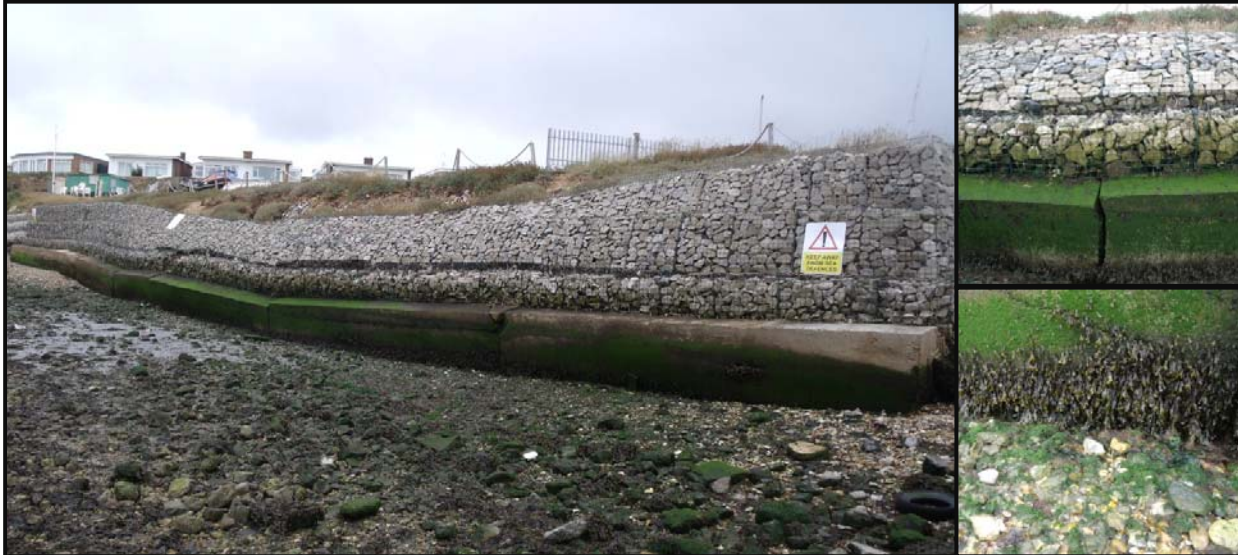
Figure 5: *general arrangement of Defence Length 4, including detailed images of undercutting and large toe wall cracks*

Condition Description: The gabion wall appears to have suffered an overturning failure which is thought to be the cause of undermining to the mass concrete toe wall. The gabion wall should have been built to stand free of the toe wall, it is uncertain as to whether the structural arrangement of the gabion units is sufficient for stability during the long term. The toe wall is exhibiting large tension cracks and undermining (see Figure 5 above). The wire mesh is showing signs of corrosion but the stone packing is good and most of the gabion units are intact.

Condition Grade: 4 – Poor, defects that would significantly reduce the performance of the asset

General Comments: The gabion wall is exhibiting instability and is considered a health and safety concern. In addition, a large storm may result in complete failure and loss of the existing structural components, reducing or preventing re-use of the existing structure.

Option 1: Salvage gabion units and re-construct gabion and toe wall – most of the gabion units are intact and could be re-used to construct a gabion wall with greater stability. A new toe wall will protect the bottom gabion units from corrosion and wave attack. The new toe wall should extend sufficiently below bed level to provide contingency for future scour.

Option 2: Gabions used for repairs to other defence lengths and a continuation of the king pile wall – the gabion units could be salvaged to repair/defend other areas and defence length 6 extended to the slipway.

Option 3: Replacement of gabion wall wire mesh – the structure is showing visible corrosion of the wire mesh and in time this will lead to damaged units, a loss of stone fill and the beginning of gradual collapse.

A combination of options should be considered. This defence needs repairs to fulfil its function in the immediate future and will require continued maintenance to wire mesh on an ongoing basis.

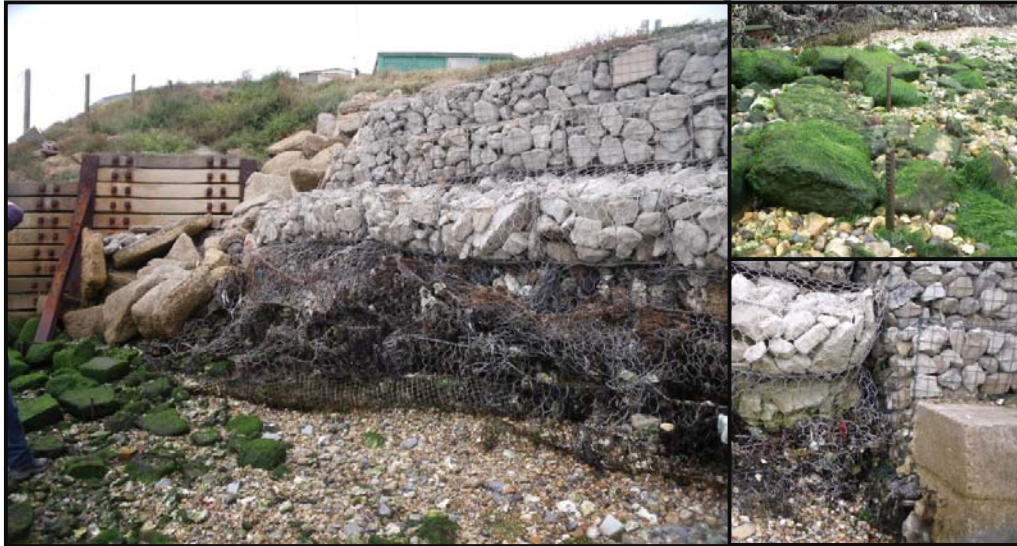
Figure 6: general arrangement of Defence Length 5, including images of protruding bars and broken gabions

Condition Description: The gabion wall has broken units with complete loss of stone fill along the toe where the structure is regularly subjected to the tide. Scour and undermining at the toe has begun and whilst the structure is not showing signs of crest settlement, the structure will rapidly deteriorate over the short term. The gabion wall thickness is severely reduced and the wire mesh is corroded. Structural movement is anticipated to follow. The concrete block revetment has some displaced units from the core structure but appears stable.

Condition Grade: 2 – Poor, defects that would significantly reduce the performance of the asset

General Comments: Steel reinforcement bars were witnessed protruding from the ground and are a health and safety and environmental concern. These would ideally be removed or at least cut back so as to reduce the hazard present. The concrete units which have become displaced would be usefully placed back into the revetment structure.

Option 1: Replace gabion units at the toe and provide a mass concrete toe wall – the existing gabion wall could be maintained and additional units placed at the toe to replace those broken. A mass concrete toe wall (such as Defence Length 4) would help to protect the wall from corrosion and wave attack at the toe of the structure.

Option 2: Gabions used for repairs to other defence lengths and a continuation of the king pile wall – the gabion units could be salvaged to repair/defend other areas and defence length 6 extended to the slipway.

Option 3: Replacement of gabion wall wire mesh – the structure will over time develop corrosion to the wire mesh and this will lead to damaged units, a loss of stone fill and the beginning of gradual collapse.

A combination of options should be considered. This defence needs repairs to fulfil its function in the immediate future and will require continued maintenance to wire mesh on an ongoing basis.

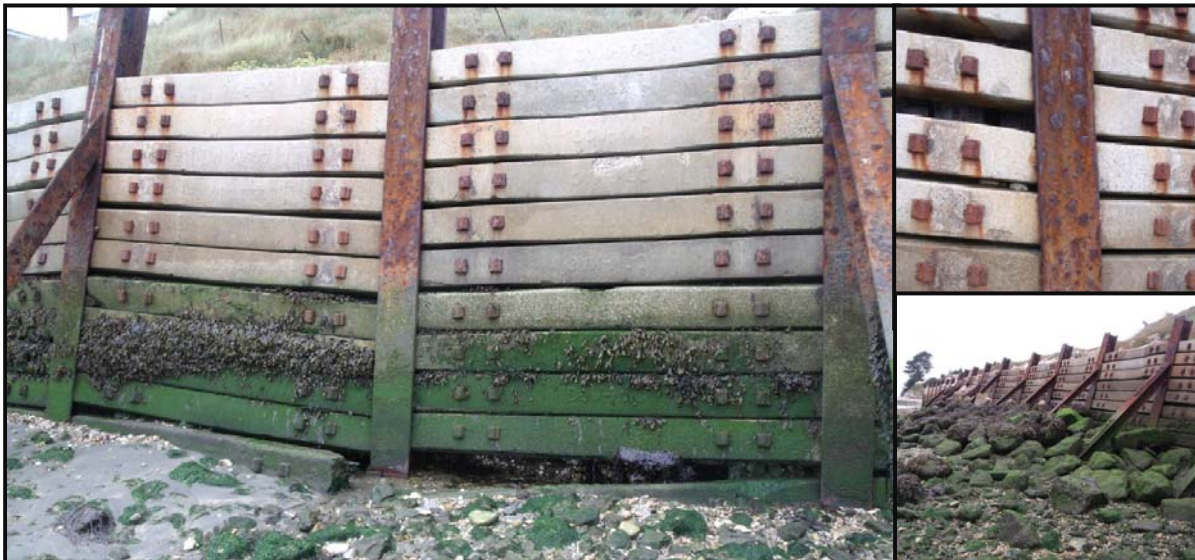
Figure 7: *general arrangement of Defence Length 6, including images of corrosion and rock armoured toe*

Condition Description: The wall has good alignment with minor slump and heave and minor lateral movement. There is evidence of localised scour (see Figure 7) and a minor loss of backfill in locations. There is extensive corrosion visible but no holes were present, suggesting a minor loss of material thickness. Nearly all railway sleepers remain intact with exception to a few (as shown in Figure 7). There are gaps developing between sleepers, allowing water ingress and backfill to be washed out.

Condition Grade: 3 – Fair, defects that could reduce the performance of the asset

Option 3: Monitoring of the wall and ad hoc repairs – in some areas there are not props and loss of backfill has begun, as well as scour. A monitoring program will help to identify if there are any local damage/failures which could be repaired before further damage results. Repairs could be providing further props, welding plates where corrosion has created holes, replacing concrete sleepers and moving displaced rock armour back to the toe of the wall.

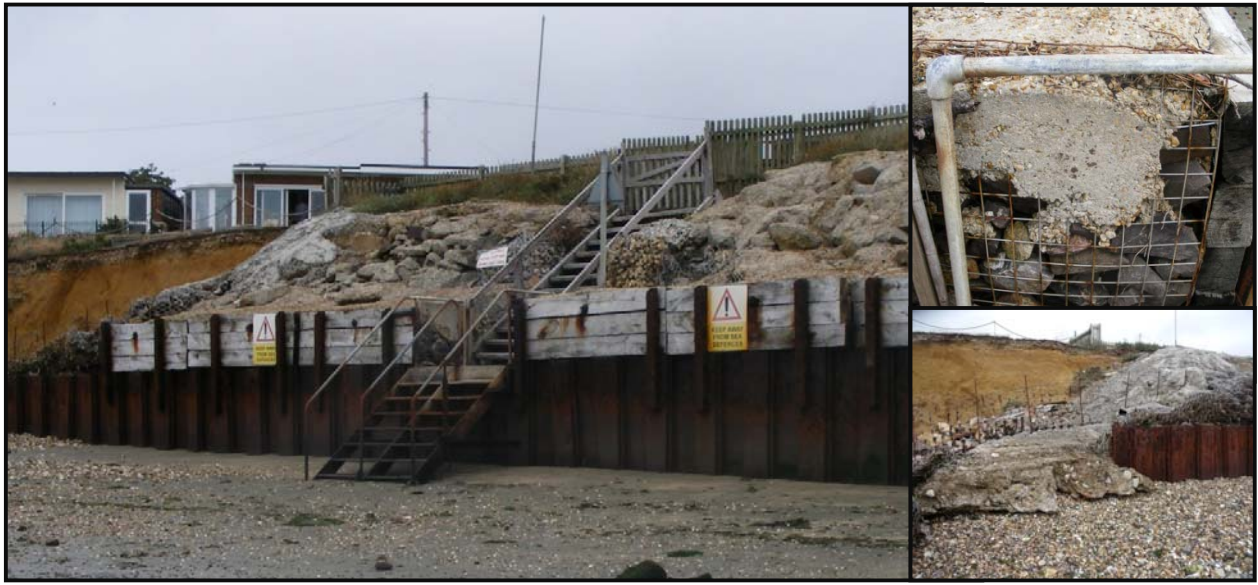
Figure 8: *general arrangement of Defence Length 7, including images of mass concrete pours and gabions*

Condition Description: There is extensive corrosion throughout the sheet pile wall. The timber railway sleepers are cracked in places but in general are in reasonable condition. There are no signs of localised scour, slump or heave and the wall is not deformed. The wall has minor vertical and lateral movement. The concrete placed behind the wall is of pour quality and it is uncertain as to how long it will last.

Condition Grade: 3 – Fair, defects that could reduce the performance of the asset

General Comments: In the longer term the structure would benefit from a more formalised end condition on the western extent (Chainage 214m) to prevent the structure weakening due to corrosion, localised erosion (increasing outflanking) and wave attack. The existing mass concrete looks of low quality and will erode, leading to a loss of protection at the structures' western end. Also, a more suitably placed fence would improve health and safety measures in this location. The timber steps appeared to be in poor condition and their structural integrity and safety is uncertain.

Option 2: Fencing improvements – the existing fencing is in poor condition and is positioned randomly due to the ad hoc arrangement of the defence lengths end. Replacing this fencing is advised for health and safety given the location is a point of access.

Option 3: Replacing timber steps – timber steps should be replaced to enable safe access in the long term to the beach, the current steps appear to be in poor condition.

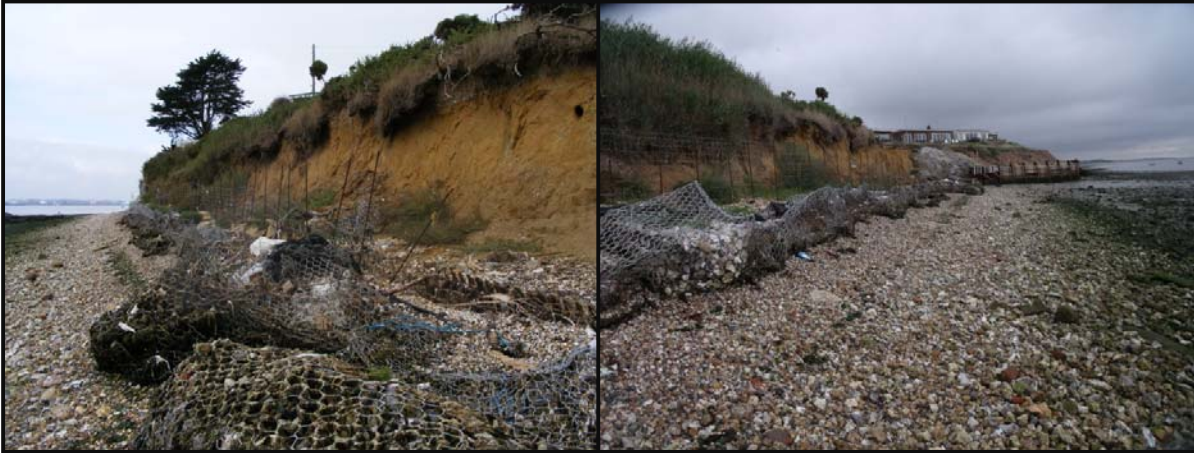
Figure 9: *general arrangements of Defence Length 8*

Condition Description: The gabions are showing substantial loss of stone, failure of wire mesh, washout and movement of units, misalignment, crest reduction and are beyond economic repair.

Condition Grade: 5 – Very Poor, severe defects resulting in complete performance failure

General Comments: This frontage length has a considerable amount of wire mesh from broken gabion units. This is unsightly and a health and safety and environmental concern. The beach levels in this location healthier and local material is visible on the foreshore. The fencing appears to be in reasonable condition.

Option 1: Site clearance and construction of a rock toe - site clearance will facilitate a clear and consistent frontage length on which to build upon. The defence line would also be brought back to the foot of the fencing as opposed to the foot of the existing failed defences. A rock toe will provide protection to the foot of the cliffs from erosion and reduce cliff recession.

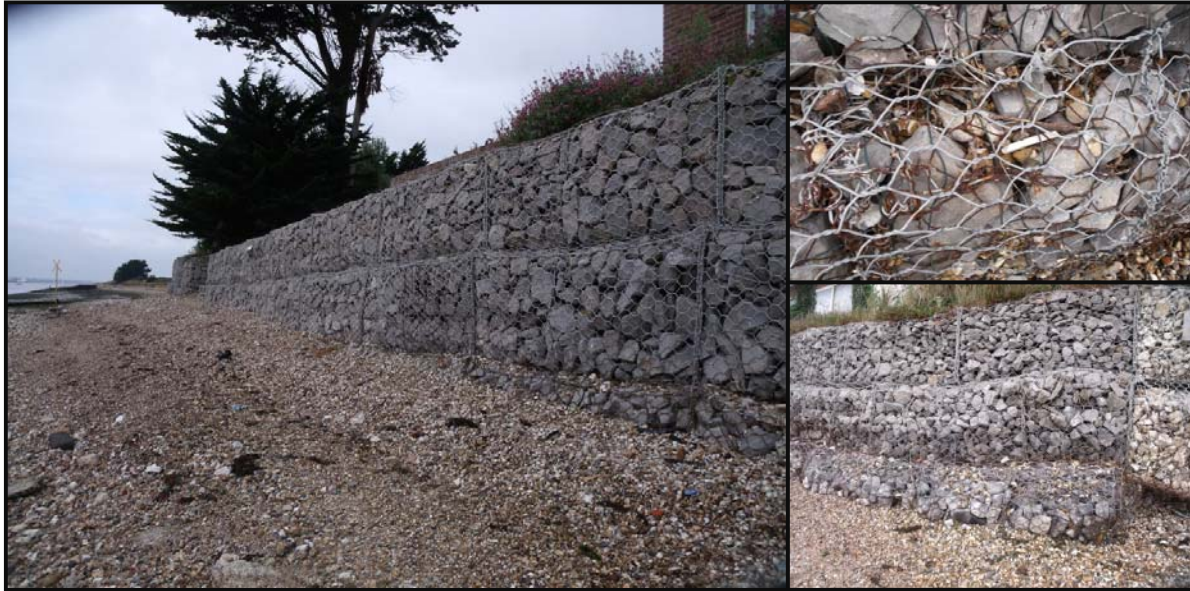
Figure 10: general arrangement of Defence Length 9, including detailed images of mass concrete pours and gabions

Condition Description: The baskets are fully intact and secure with no evidence of undermining or toe scour. Minor bulging is visible at the eastern end of the defence length. There is visible corrosion, however, there is evidence that gabion wires have been replaced (See Figure 10). The baskets are well packed and are at maximum density with small distortions of baskets and alignment, minor crest settlement.

Condition Grade: 2 – Good, Minor defects that will not reduce the overall performance of the asset

General Comments: This defence length has healthier beach levels compared with other defence lengths, likely as result of the neighbouring outfalls which are behaving as large onshore groynes, trapping beach material in this area and preventing its further north-westwards transport along the shoreline. The defence has a poor eastern end condition (chainage 248m) which appears to be resulting in the start of structural defects.

Option 1: Improvements to eastern end of defence length – replacement of damaged gabions and/or additional units placed at this location to prevent further damage which could lead to progressive failure and outflanking.

Option 2: Replacement of gabion wall wire mesh – the structure will over time develop corrosion to the wire mesh and this will lead to damaged units, a loss of stone fill and the beginning of gradual collapse.
