Lymington to Yarmouth Ferries: Mitigation and Monitoring (2020)

Five-year update and 10th Report for the
Environment Management Panel

December 2020

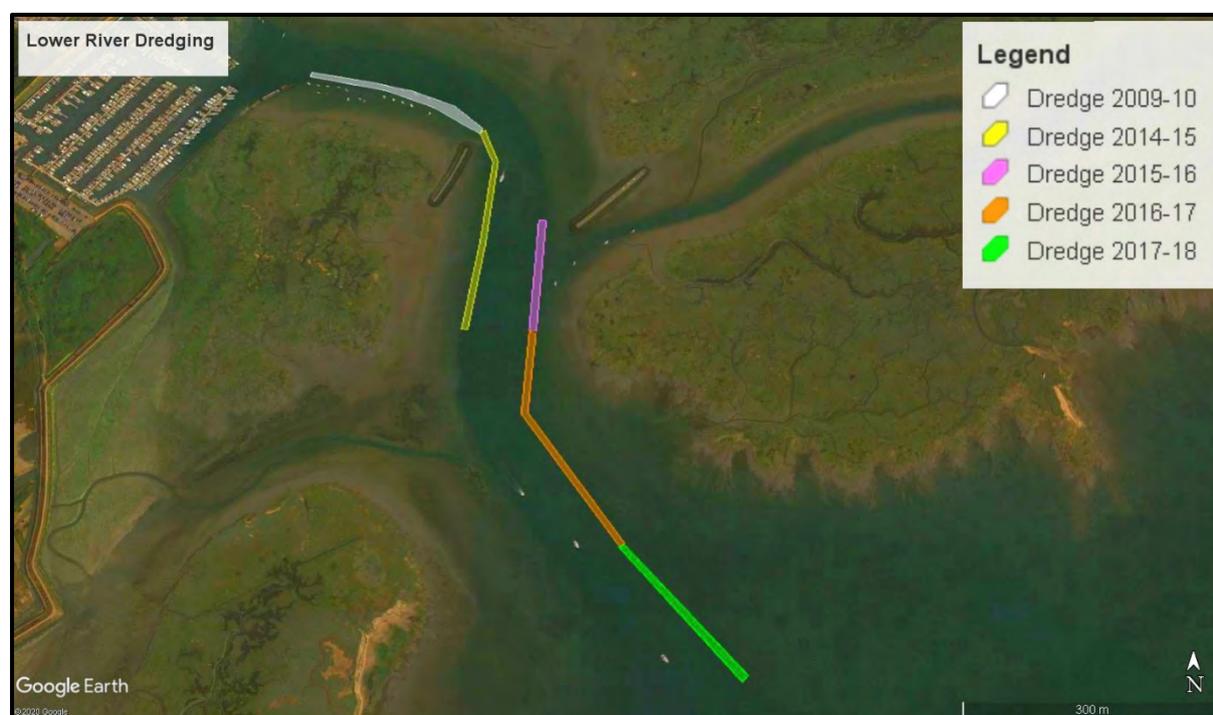
Image 1. Location and timing of LHC lower river maintenance dredging campaigns

Firstly, the Lymington Harbour Commissioners (LHC) carried out a sequence of maintenance dredge campaigns along the margins of the main approach channel. There were five campaigns from 2009 to 2018. These were each undertaken over the winter months (between October and February). Details of the locations and timing of this dredging work were provided by LHC (as illustrated in Image 1).

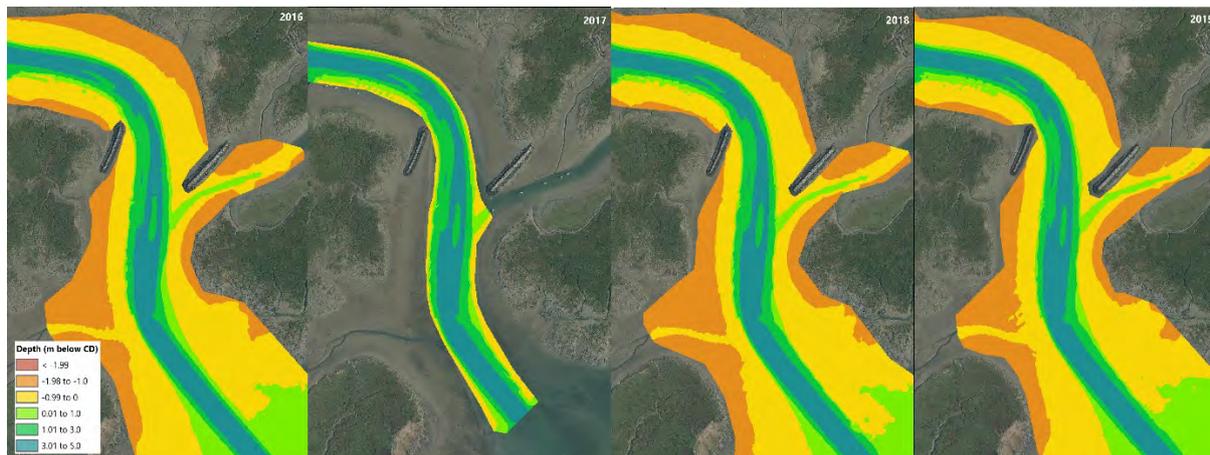
Image 2. Overview of bathymetric surveys carried out by LHC (2016 to 2019)

To describe the morphology of the estuary and identify changes that have occurred in recent years, the latest bathymetric data was provided by Lymington Harbour Commissioners (LHC). The LHC regularly carries out bathymetric surveys to inform their maintenance of the navigable approaches and to assess the effectiveness of dredging campaigns. Four such surveys have been conducted since the last EMP report was produced. These were carried out in May 2016, June 2017, January 2018 and September 2019 (see Image 2).

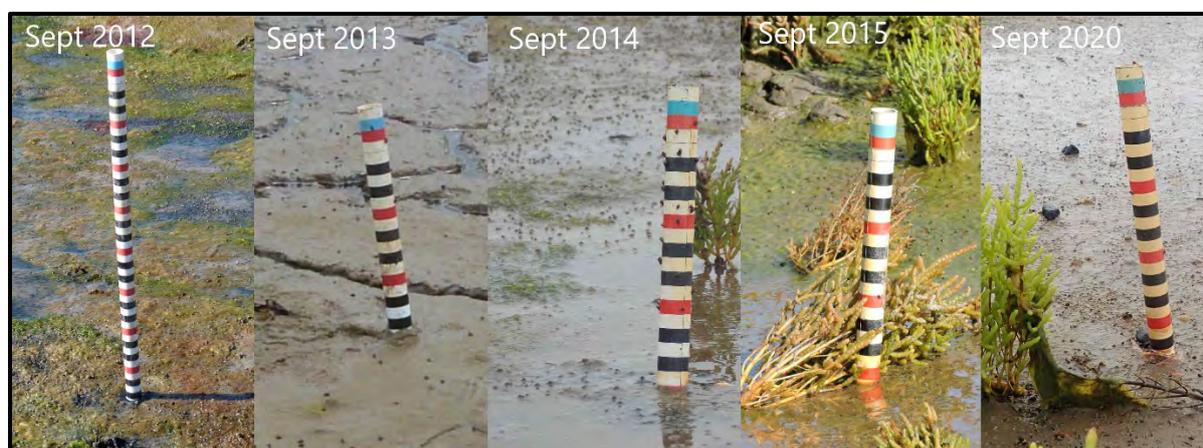
Image 3. Stake I before and after 2012/13 recharge work (for site location see Figure 5)

As shown in Table 1, reductions in bed level occurred at most of the visible graduated stakes between 2015 and 2020. These stakes are mainly in the northern half of the recharge area where generally elevation has lowered by a further few centimetres since 2015. This is illustrated by Stake I and Stake A (as shown in Image 3 and Image 4 respectively).

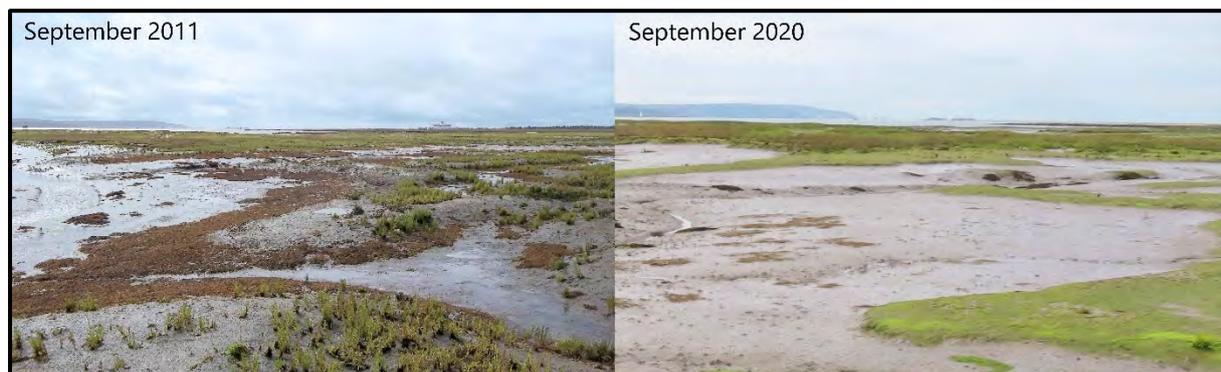
Image 6. View south west from Boundary Post 1 (BP1) before the recharge and in 2020

The LiDAR cross sections in Figure 6 and Image 5 also show that there has been net accretion in areas outside the recharge area to the south (i.e. seaward of the main deposition area). To illustrate how this has influenced the habitats, Image 6 show views of the area to the south of the recharge site before and after the recharge (in 2011 and 2020). As suggested in previous monitoring reports, this accretion is likely to be occurring because of reduced volumes and speeds of water flow though this area on each tide.

This accretion indicates that more stable conditions have been created beyond just the location of the recharge area itself. It is possible, that some of the recent LHC beneficial use deposits in front of Boiler Marsh (see Figure 3 and Figure 4) may be contributing some of the sediment that is accreting in this area.

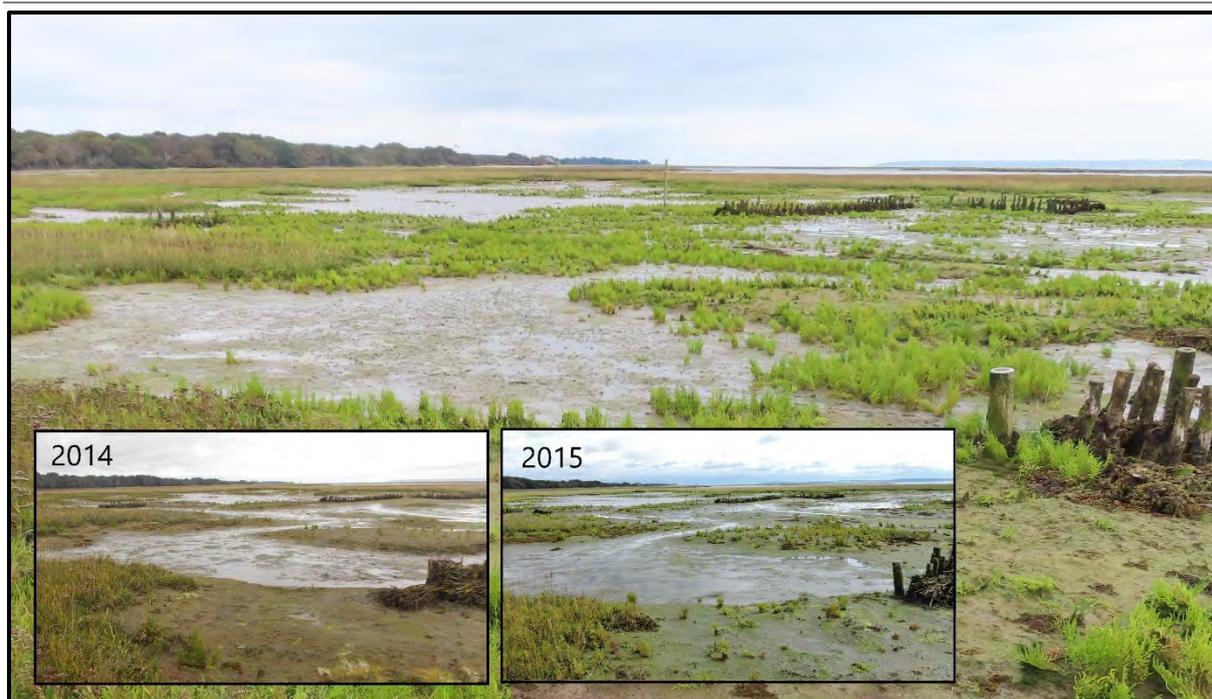
Image 7. View north west from Boundary Post 2 (BP2) from 2014, 2015 and 2020

To illustrate this change, photographs of the central section are shown in Image 7. These were taken from Boundary Point 2 in 2020, 2015 and 2014. This denser coverage of *Salicornia* on the northernmost fringes of the site is illustrated by the photographs taken from Boundary Post 3 which are shown in Image 8. These photographs describe conditions at the top of the recharge area before, and in the years after, the recharge work.

To some degree, the difference between 2015 and 2020 will be a function of variability in weather conditions over the preceding summers leading to differences in the timing and extent of *Salicornia* growth. This is probably the case across the central section. However, there does appear to have been some slight accretion in front of BP3 (Image 8). This is evidenced both by the increase in plant density and the maturing of a small drainage channel that runs through this part of the site. It is likely that the growth of *Salicornia* after the recharge has helped to trap sediment and contributed to this modest and localised sediment accretion.

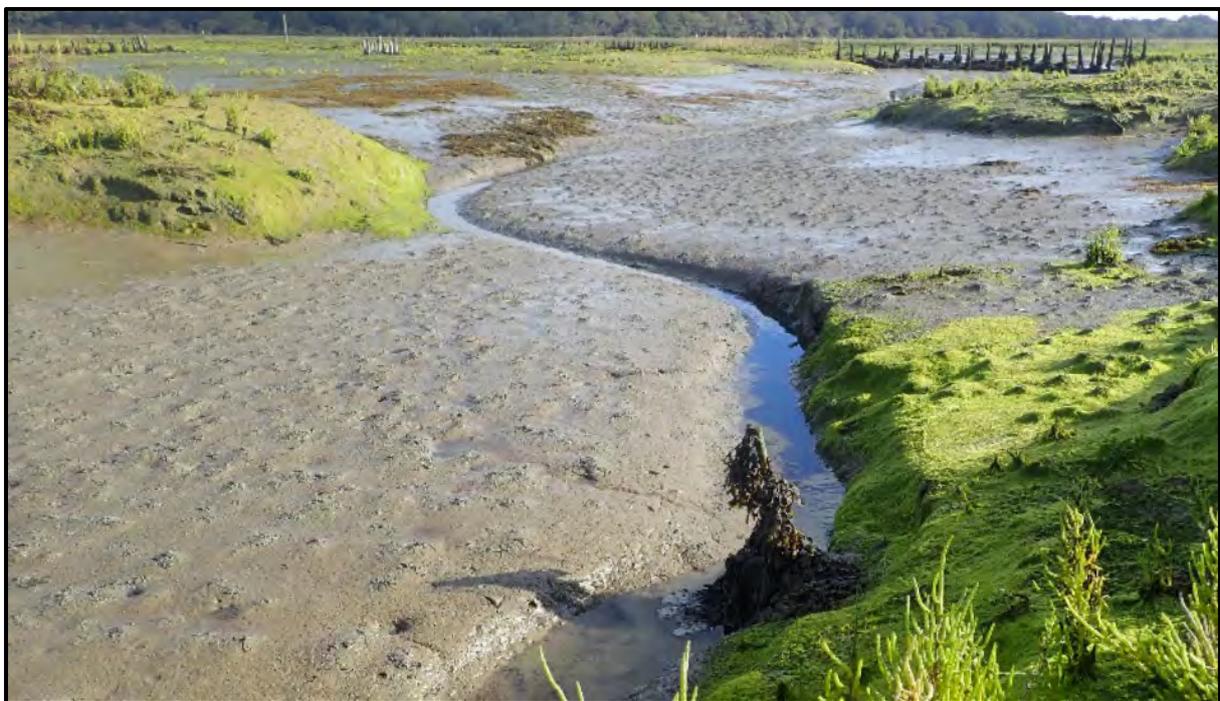
Image 9. View north from Boundary Post 8 (BP8) showing mudflat and internal fencing

In general, therefore, there was no indication of a notable change. Based on the recorded data and onsite observations, the quality of the surrounding marshes appeared to be the same as in previous years

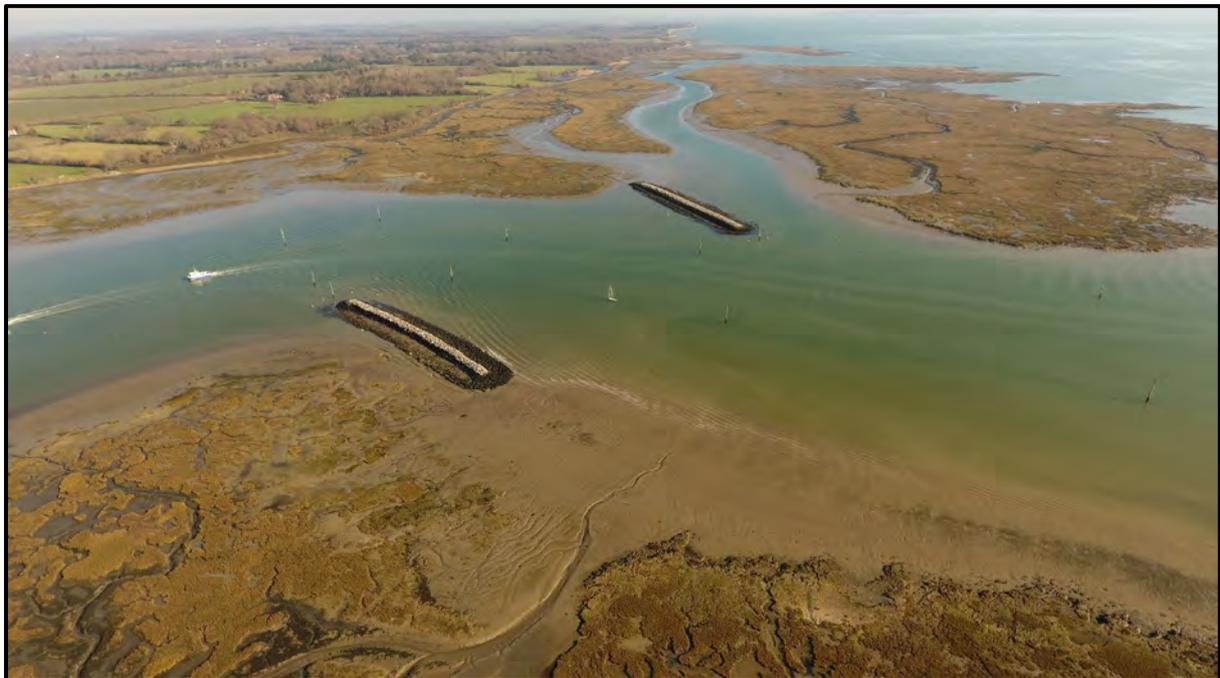
Image 10. View east over the Lymington River (February 2019)

In the more sheltered areas inside the channel (i.e. away from the estuary mouth), there are clear signs of accretion around the rock armour breakwaters. This is especially evident on the western side of the channel. The LHC recharge that was carried out in 2012 and 2013 is also visible. Figure 3 and also Image 10 provide further descriptions about these key features.

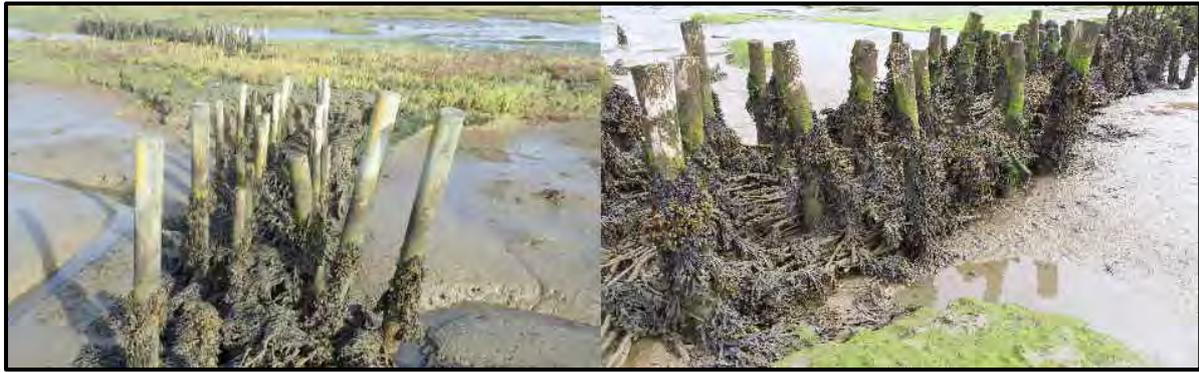
Image 12. View of outer fences line from Boundary Posts BP9 (left) and BP1 (right)

It is also encouraging that no substantial damage has occurred to the basic structural framework of the protective fences that define the site and the area of the original sediment deposition. Many of these fences remain at least partially buried in the sediment and others that are more exposed have lost internal bales and some of the poldering that is inter-woven through the main posts. However, the main posts and much of the poldering still remain and the lower-lying outer fence are covered in *Fucus spiralis* (see Image 12) that will help to restrict flow speeds through the fences and will assist with sediment retention.

Given that much of the dredge sediment remains in place after nearly eight years, that the environment more broadly has clearly been altered by this work and the fences have retained a good degree structural integrity, it is likely that this site will remain in a good condition for several more years (perhaps a decade or more).

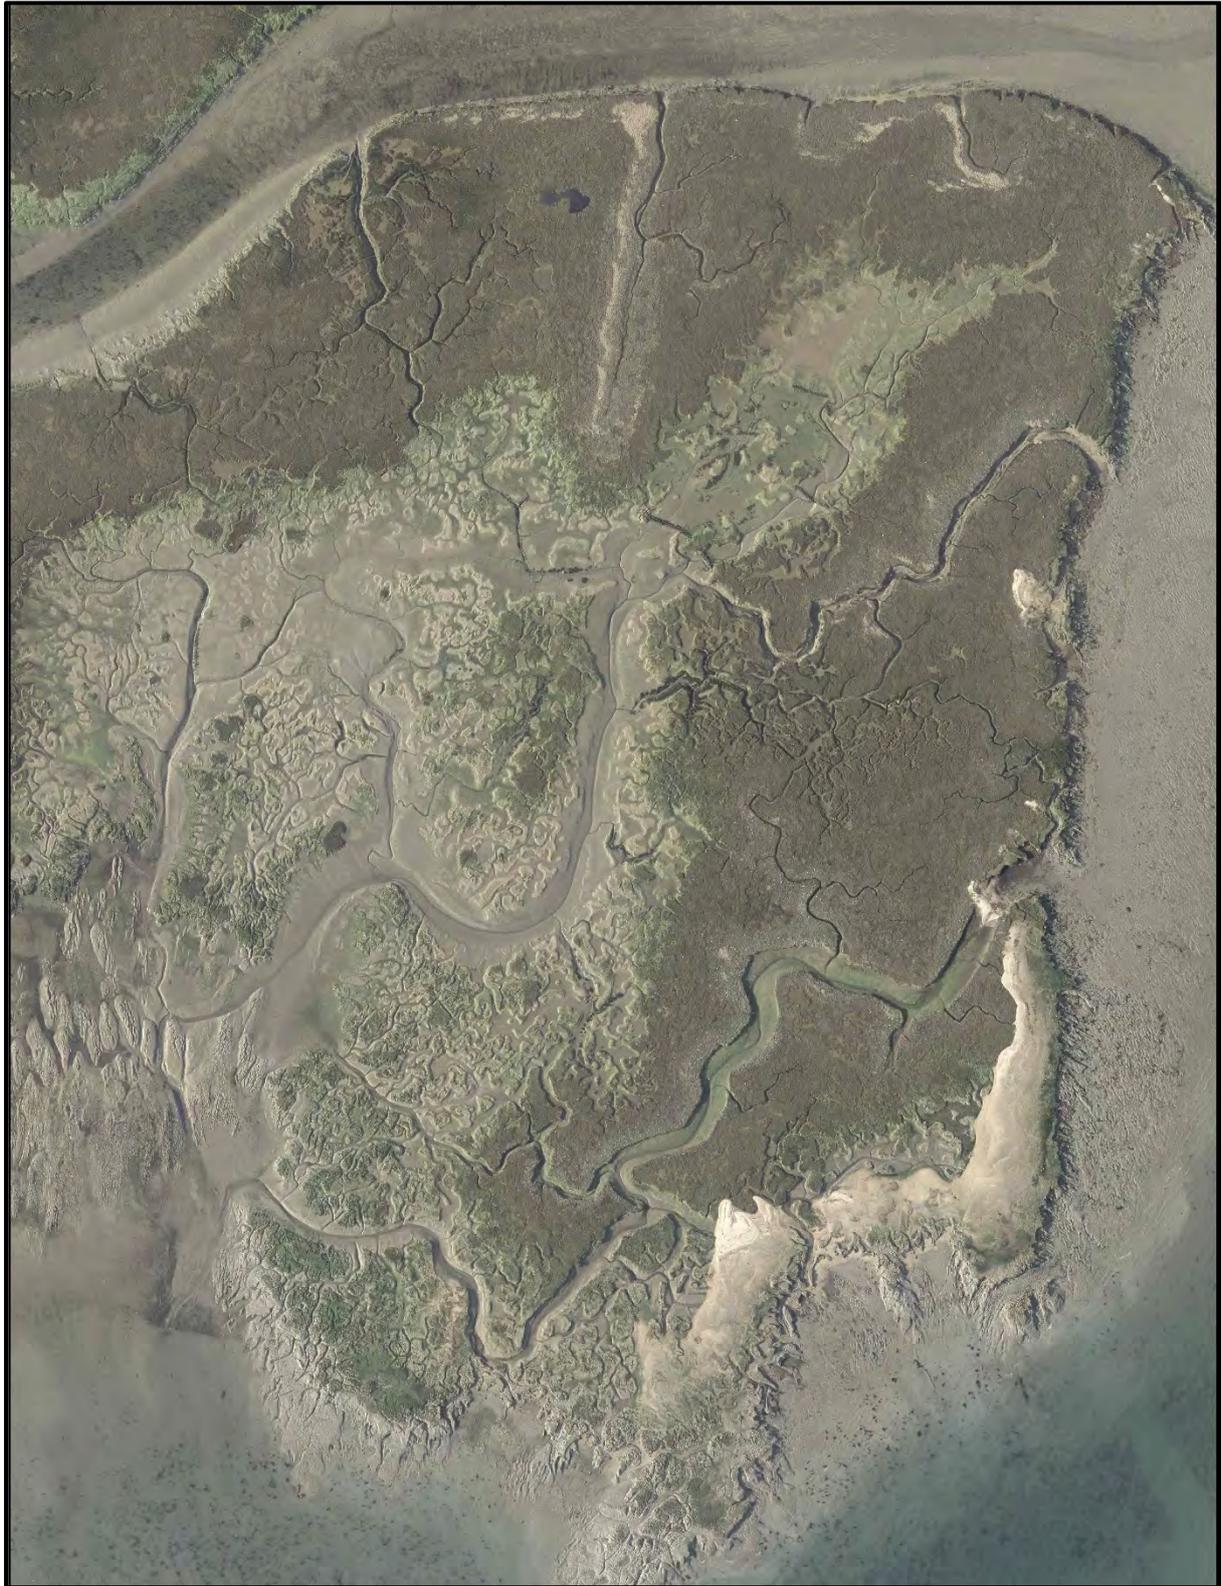
Image 13. April 2019 aerial view of eastern Boiler Marsh (CCO website)

The major concern for the Boiler Marsh, and other marshes locally, of course, is that they are continuing to erode on their outer faces. Image 13 shows an aerial image of the eastern Boiler Marsh (from April 2019) to illustrate the position of the recharge relative to the eroding outer edges.

This process is not something that can be, or needs to be, substantially influenced by the Wightlink recharge and is unrelated to the mitigation requirements in this case. However, it is recognised that many regional stakeholders aspire to use much greater volumes of dredge sediment to further protect these marshes in the future. This has been the focus of the Solent Forum BUDS project. The Wightlink recharge site with its fences still largely in place could become a valuable receptor site for such sediment in the future. For this to happen, though, the EMP would have to be assured that the site is no longer needed for the specific purposes of mitigating the ferry operations.

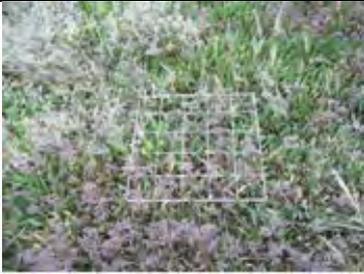
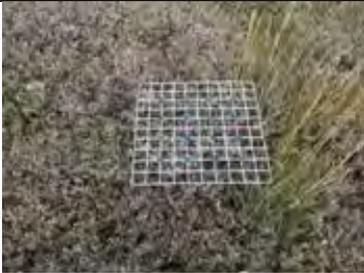
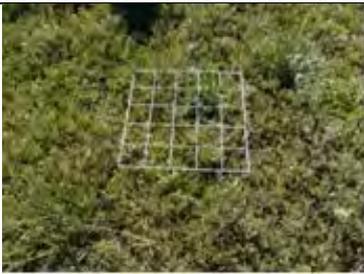
Table A14. Saltmarsh Quadrat Photographs 2010 to 2020 (Quadrats 10 and 11)

Saltmarsh Quadrat No	Quadrat No. 10	Quadrat No. 11
Marker Colour Code (used from 2012)		
Actual Position X	435268.85	
Actual Position Y	94950.13	
Baseline Survey 2 14 September 2010

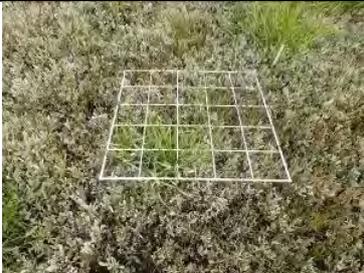
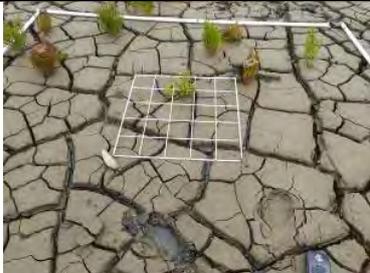
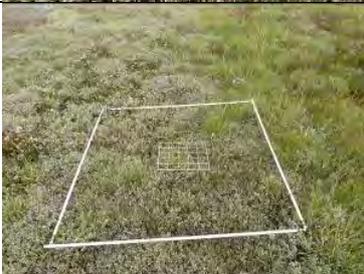
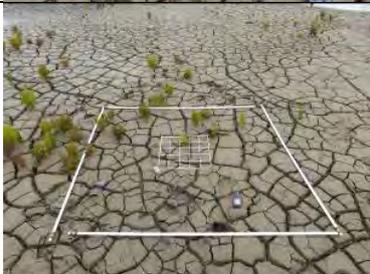
n/a
11 September 2013 (0.5 m ² Quadrat)

11 September 2013 (4 m ² Quadrat)

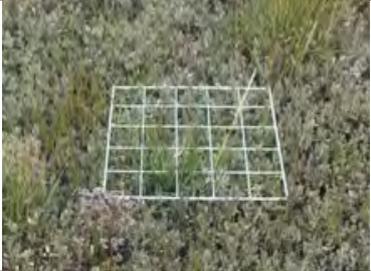
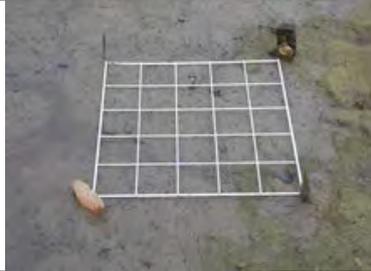
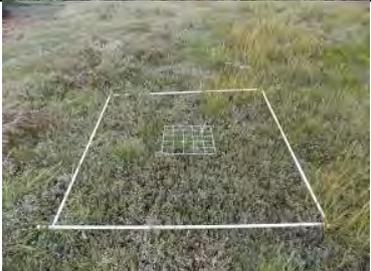
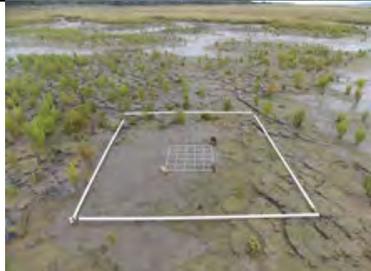
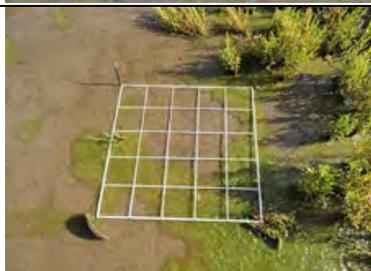
Saltmarsh Quadrat No	Quadrat No. 10	Quadrat No. 11
<p>1 September 2014 (0.5 m² Quadrat)</p>

<p>1 September 2014 (4 m² Quadrat)</p>

<p>22 September 2015 (0.5 m² Quadrat)</p>

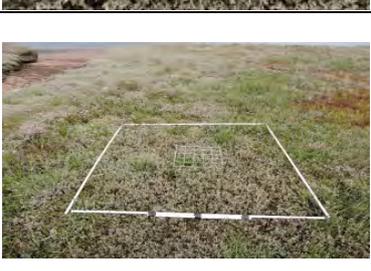
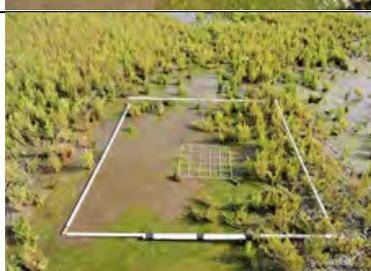
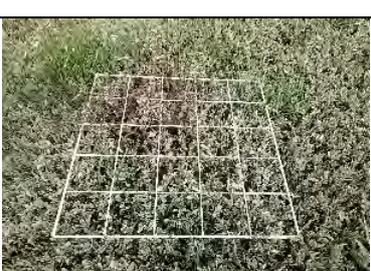
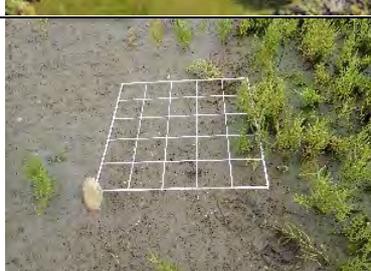
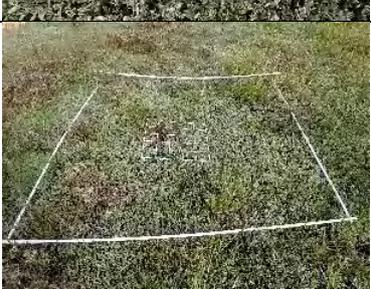
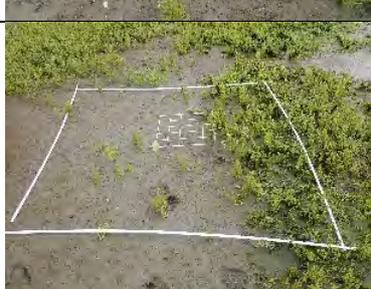
<p>22 September 2015 (4 m² Quadrat)</p>

<p>9 September 2020 (0.5 m² Quadrat)</p>

<p>22 September 2020 (4 m² Quadrat)</p>
