CCATCH @ Solent Breezes: Community Workshop on 26th September 2013

Workshop report

Solent Breezes Coastal Defence Assessment

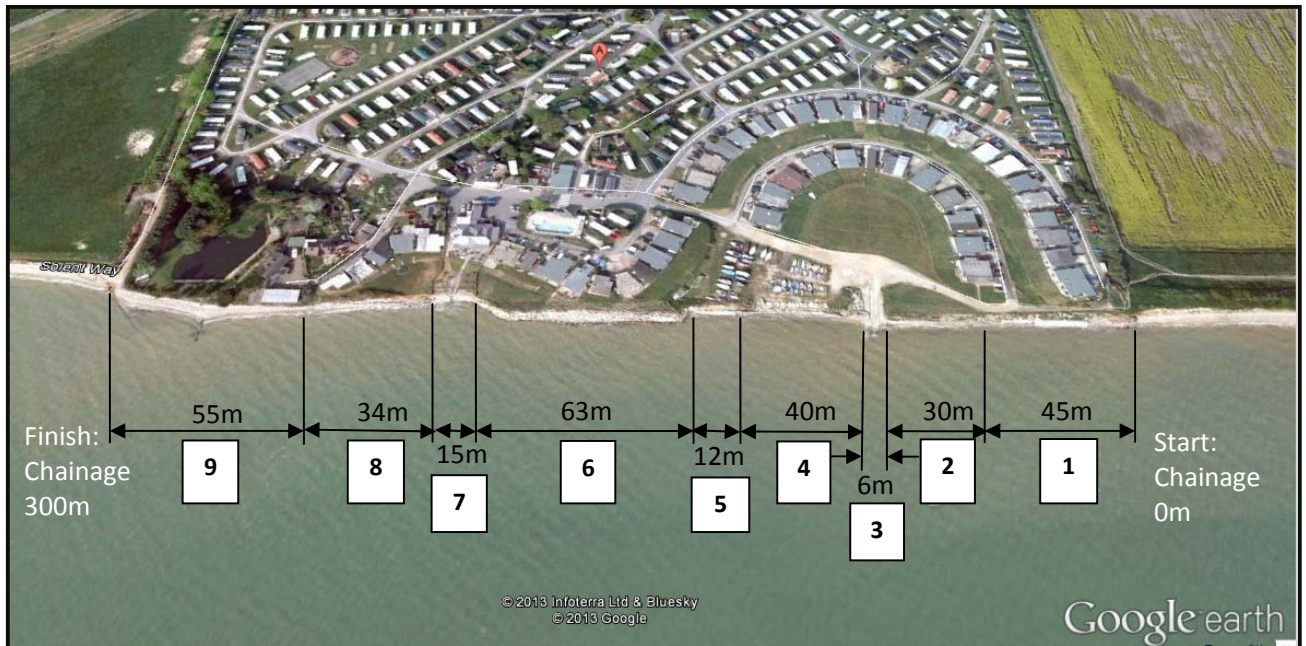
Figure 2: Solent Breezes defence lengths identified during the site visit (image copyright: Google Earth)

The Solent Breezes frontage is approximately 300m in length and comprises a range of defence types and construction methods implemented over a period of several decades. A site visit was undertaken on 12th September 2013 to conduct a visual assessment of the existing defences along Solent Breezes frontage. The site visit identified nine succinct defence lengths which are indicated in Figure 2. There are two concrete outfalls at the north-western end of the frontage extent which are outside of this condition assessment.

Each of the defence lengths identified in Figure 2 have been appraised in accordance with the CAM. The results are presented in the following sections. In some sections, potential options have been identified to maintain the life of the existing defence where appropriate over the next 1-20 years, in accordance with the SMP policy.
